BEFORE THE STATE OF MAINE PUBLIC UTILITIES COMMISSION

Docket No. 2019-00015

COMMISSION INITIATED INVESTIGATION OF METERING  
AND BILLING ISSUES PERTAINING TO CENTRAL MAINE  
POWER COMPANY.

Direct Testimony of

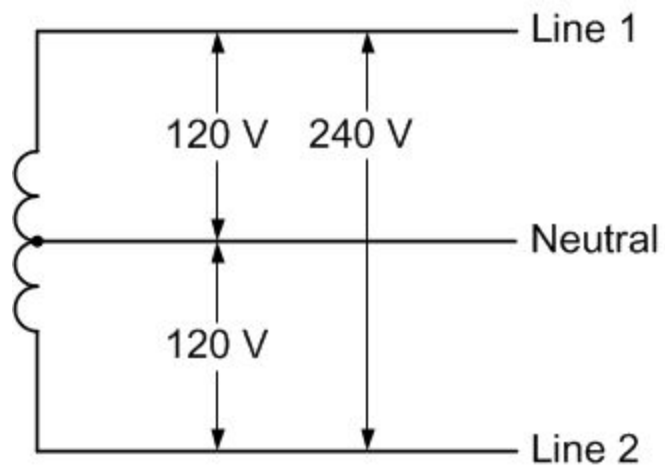
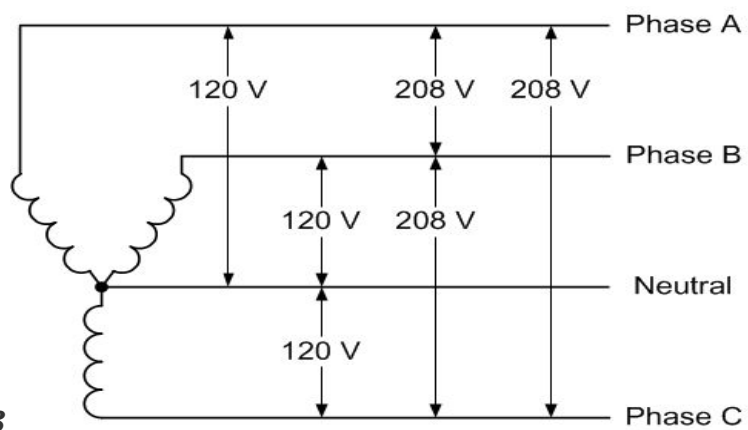
*Figure 3.4.A*

For this to be true, there wouldn't be a Phase C used for residential customers. In **Figure 3.4.A** shows a Single Phase Three Wire diagram also known as an Edison system, split-phase or center-tapped neutral. This is the most common residential service in North America. Line 1 to neutral and Line 2 to neutral are used to power 120-volt lighting and plug loads. Line 1 and Line 2 is used to power 240-volt single phase loads such as a water heater, electric range, or an air conditioner. In **Figure 3.4.B** shows how a Three Phase Four Wire Wye which is the most common commercial building electric service in North America is 120/208-volt wye, which is used to power 120 volt plug loads, lighting, and smaller HVAC systems. In larger facilities the voltage is 277/480 volt and used to power single phase 277-volt lighting and larger HVAC loads. In order for the Company's statements to be true about customers under registering their usage on Phase C would only be true for commercial and/or industrial customers. Many air conditioners and space heaters currently on the market are between 115v to 120v. Thus, residential customers would more than likely be overcharged by double their usage during the summer and winter months if they happened to be wired for Phase C.
